## A Survey of Thatched Buildings in Scotland

Thatch Survey of Scotland  
2014-15

A photographic survey of thatched buildings in Scotland, surveyed between May 2014 and August 2015 by Zoe Herbert (SPAB Scotland Officer), on behalf of the Society for the Protection of Ancient Buildings.

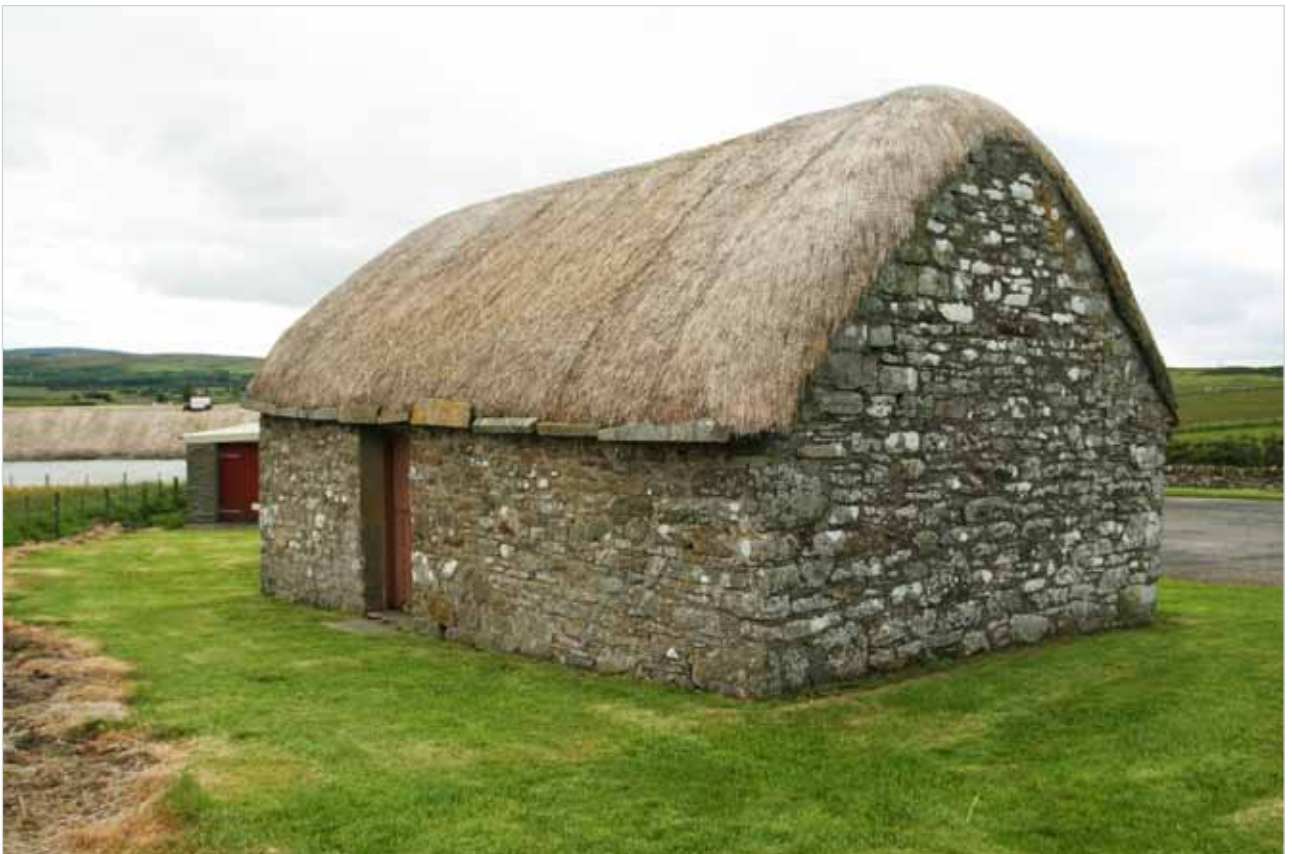
..... building has two chimney stacks along the ridge, around the base of which have been placed tiles of what appears to be turf that is held in place by the netting. There is some minor weed growth on the surface of the thatch in places, but otherwise the roof is in a well-maintained condition.

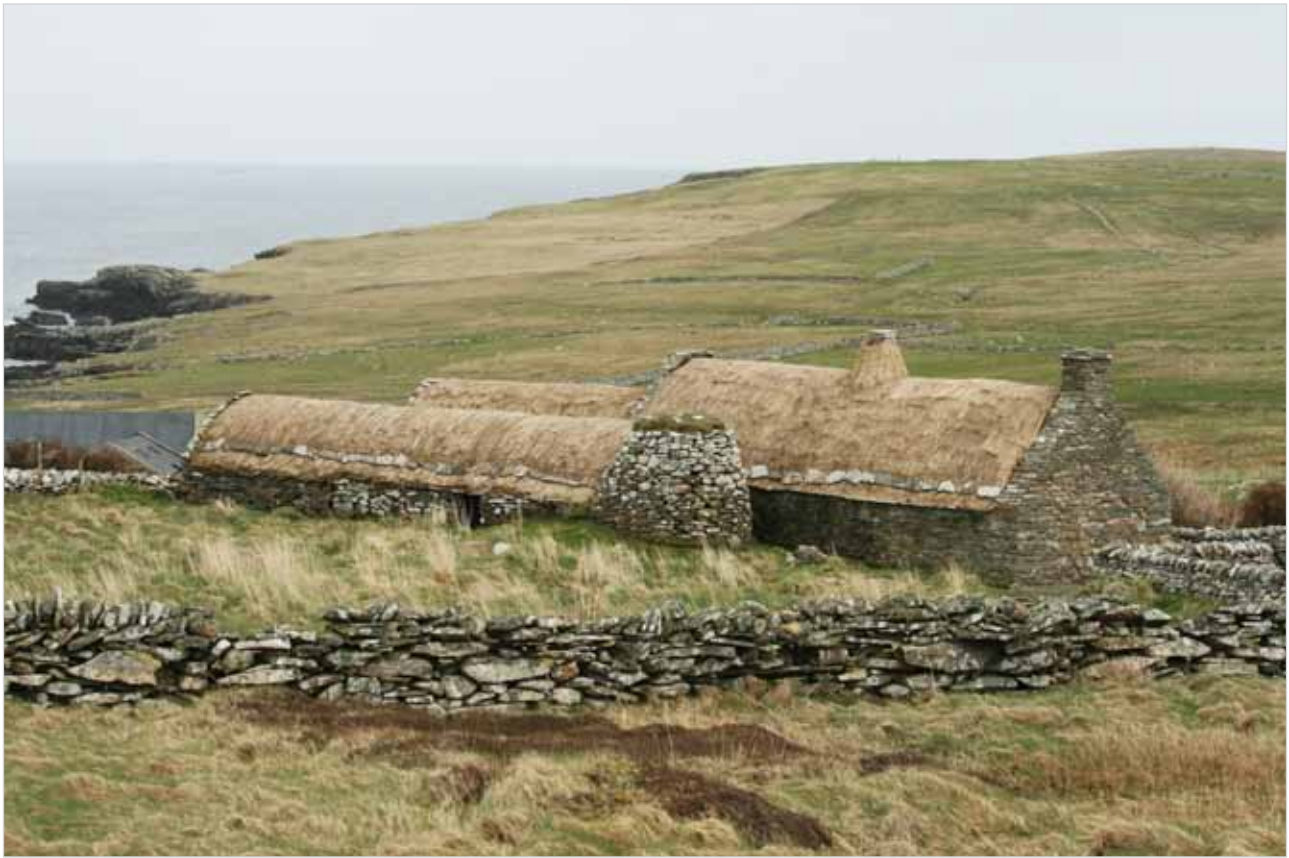
eaves on both the front (north) and back (south) elevations. Whilst the condition of the straw is good, there are a number of small openings in the thatch, along the skews and at the eaves, exposing a small amount of the buildings' interior. The roof is continuously thatched in straw across the ridge.

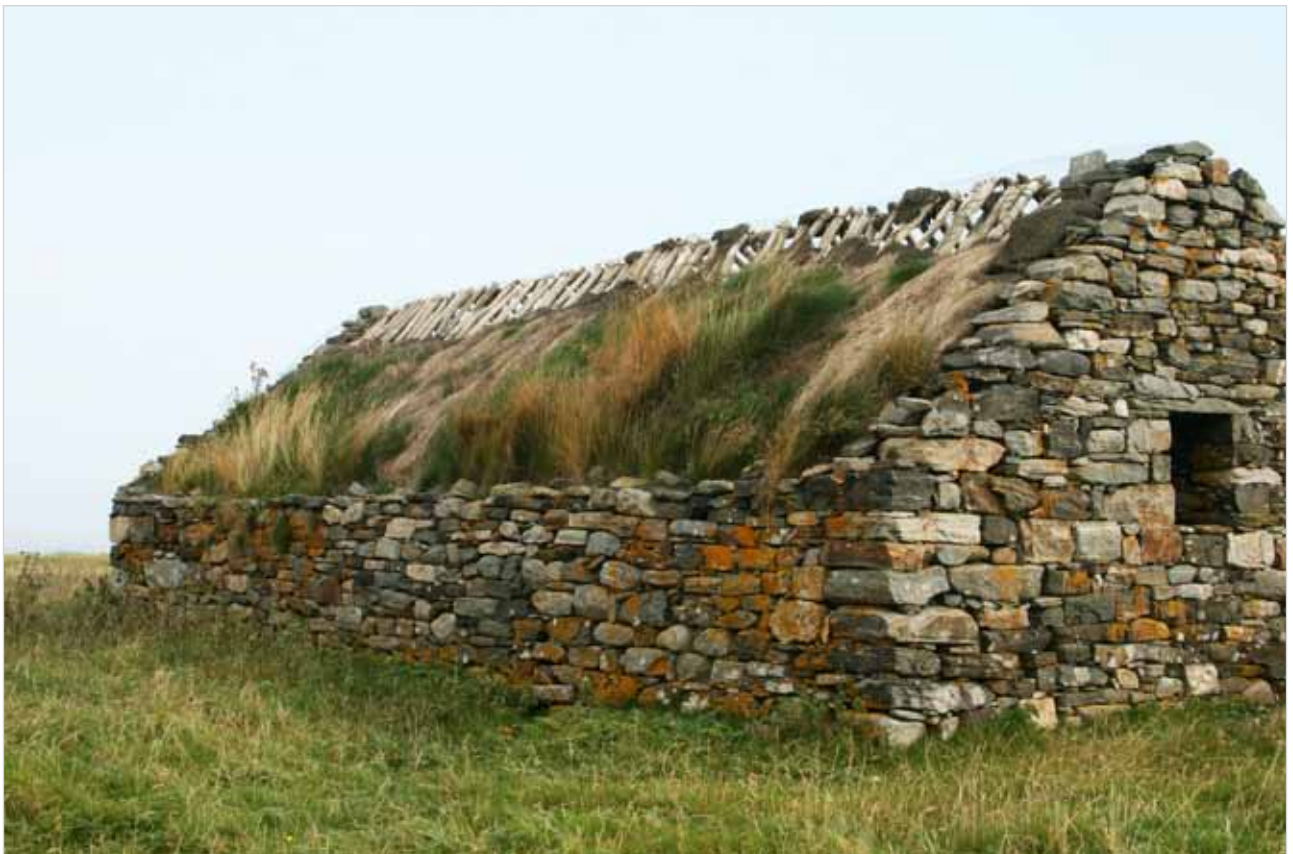
and the turf underlay is exposed in many places. The roof remains netted, held in place by stones that are secured to the netting by string along the wallhead and skews. The building is located next to a thatched byre under the same listing (survey number 248). The barn has been on the Buildings at Risk Register since 2009 (BAR reference number 3744).

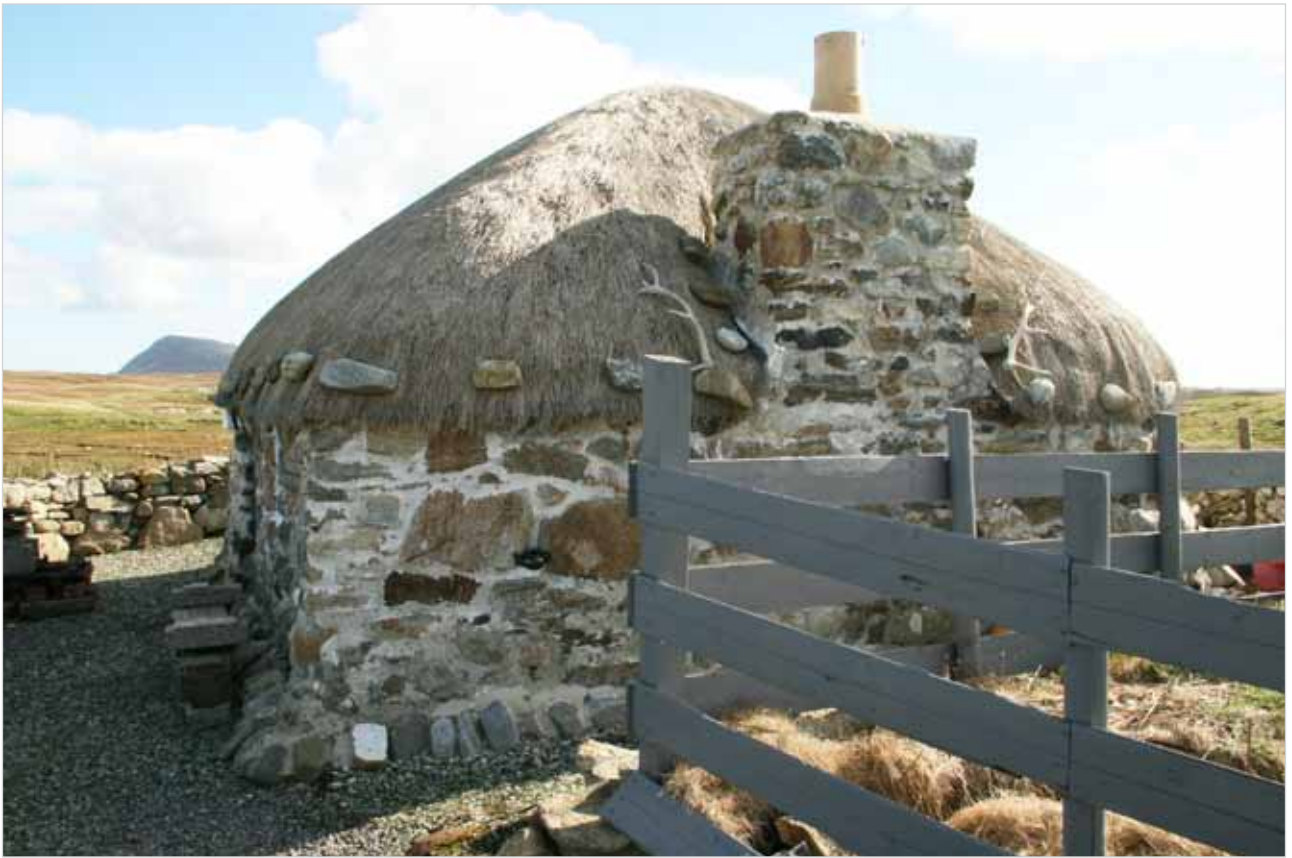
vegetation growth to the surface of the thatch on the rear elevation of the cottage and some thatch replacement/repairs appear to have taken place in the past, made apparent by the obvious difference in colour of the thatch in places.
